## APPENDIX D: Bridge Assessment Guidance

## Preliminary Bat Assessment Guidelines for Bridges/Structures

#### DOT Environmental Division

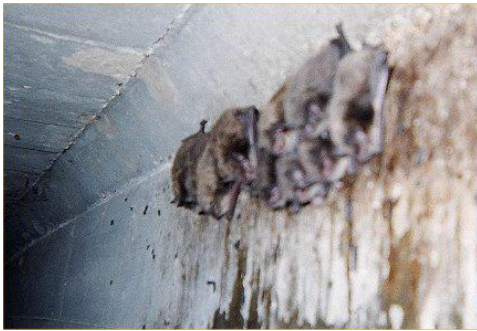
Photo 1: Bats hanging from cracks along Support beams

Cracks in the concrete are used by bats as a foothold in roosting (Photo 1). In addition, some bats may be hidden from sight in wider cracks in the concrete and behind deteriorating concrete sections in the ceiling or walls. Look for cracking along support beams and inner walls especially below a fillet (a concrete filling between ceiling and vertical beam). During inspection, sounds may be heard coming from behind such cracks and/or expansion joints.

Look for bats flying or roosting (hanging) during the assessment (Photo 1, 2, & 8). A flashlight or headlamp will be needed and binoculars may be necessary when viewing higher areas. If bats are present; record numbers as best as possible and their locations. Note any dead or injured bats. A sketch map would be helpful (can use bridge plan sheet as base for sketch). Thermal infrared cameras or emergence surveys can be used to document bat use.

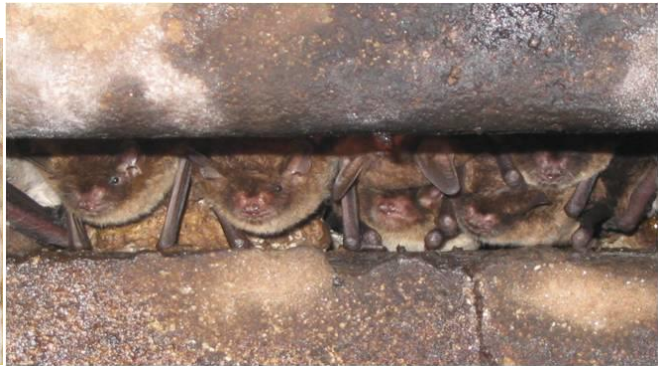
Photo 2: Visible bats within an expansion joint

Expansion joints can provide protected cover for bats (Photos 2 and 3), but do not always provide habitat, depending upon whether they are obstructed by road debris or other blockages to use. If possible during the assessment, individuals should look into expansion joints or in other cracks with a flashlight. If joints are used by bats, often there will be guano under the joints (Photos 4-6), but not always, since the joint may be located over water.

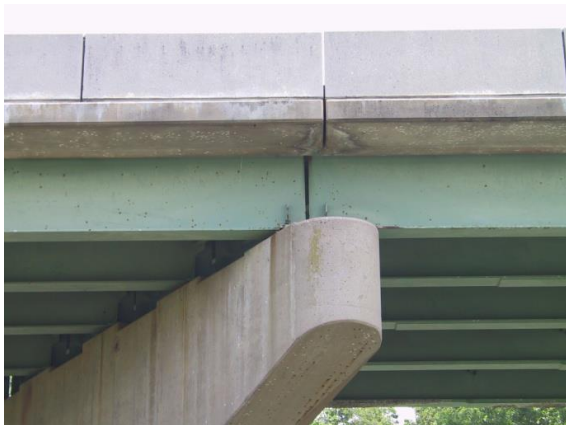
Photo 3: Example of open concrete joint used by bats

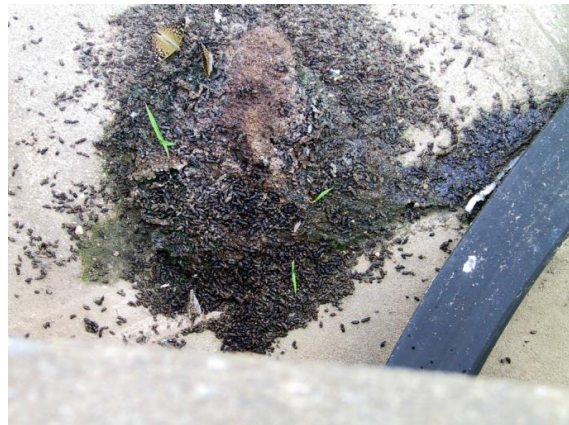
Photo 4: Guano deposits visible from bridge deck, on top of pier

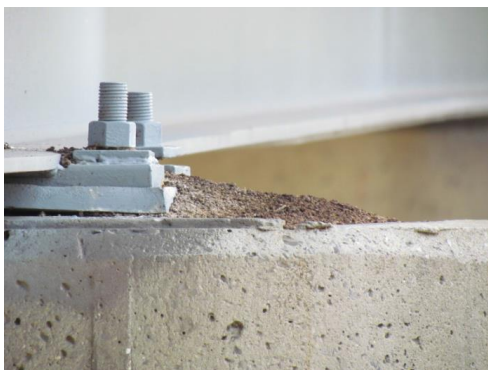
Photo 5: Guano deposit on pier, obscuring structural features.

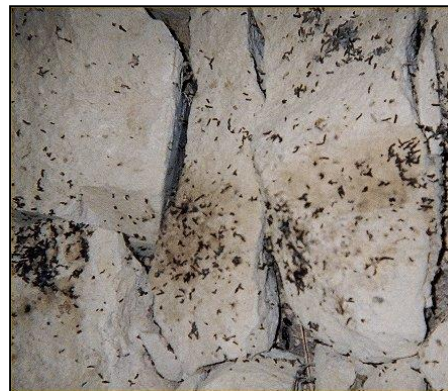
Photo 6: Bat Guano on Riprap

Bat droppings are small (mouse-like in appearance but less regular) brown or black pellets (Photos 6 - 8). Older droppings may be gray in color. These droppings will accumulate on the ground, floor of a covered bridge or on structural components below where bats roost. Droppings may also adhere to support beams and walls below roosts.

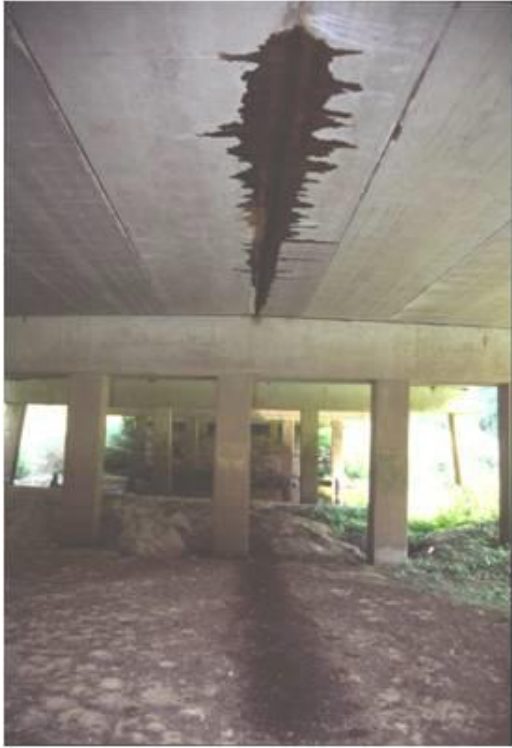
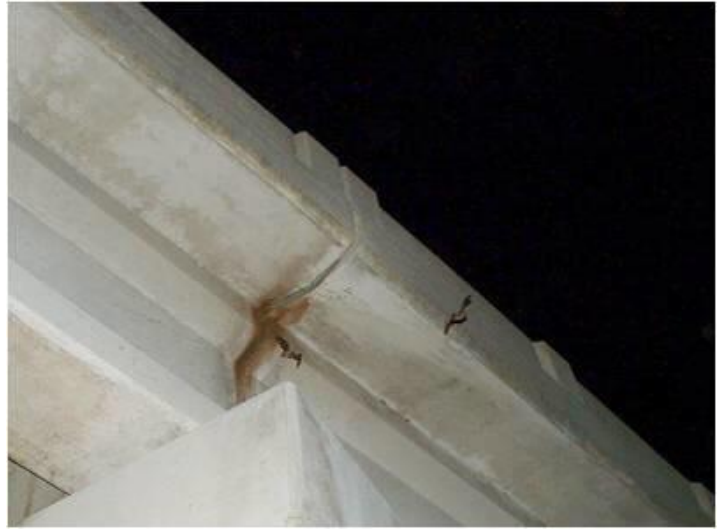
Photo 7: Staining along longitudinal joint. Note guano deposits on the ground. Photo 8: Staining on underside of expansion joint from bat use.

Stains may appear wet and are usually found in dark places. Look for four to six inch wide dark stains located on concrete support beams and walls immediately below the ceiling of the bridge, and beneath joints (Photos 8 - 11).

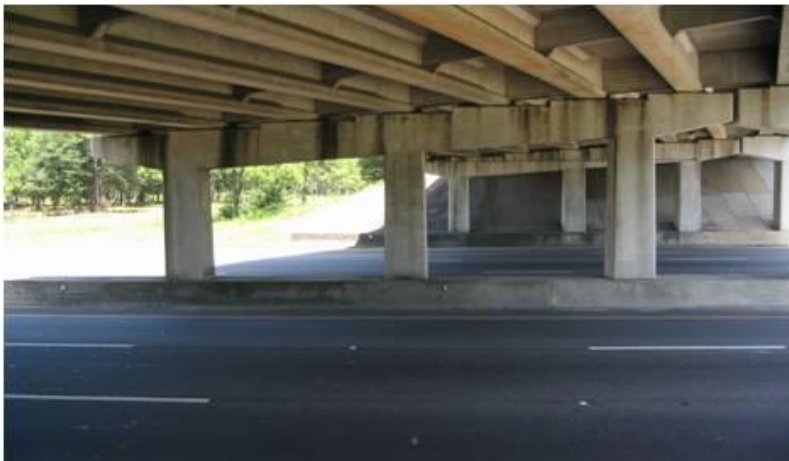
Photo 9: Staining on sides of pier caps

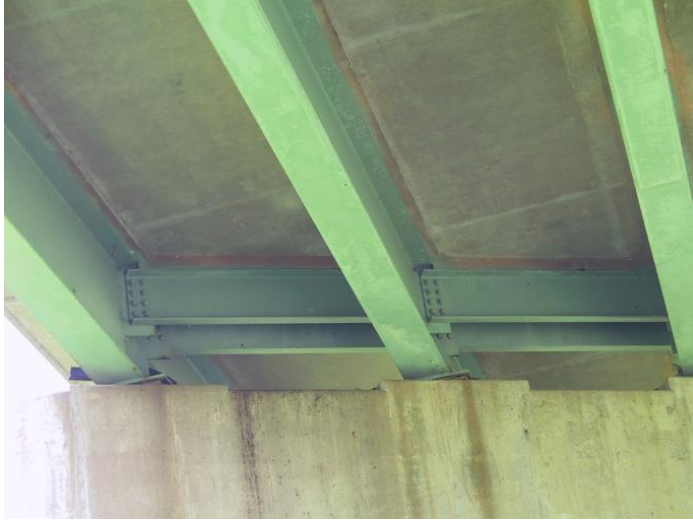
Photo 10: Guano staining on side of pier

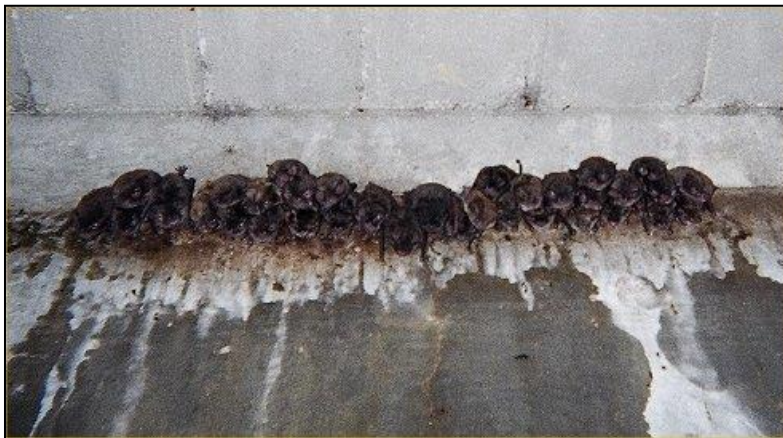
Photo 11: Bats Roosting & Associated Staining

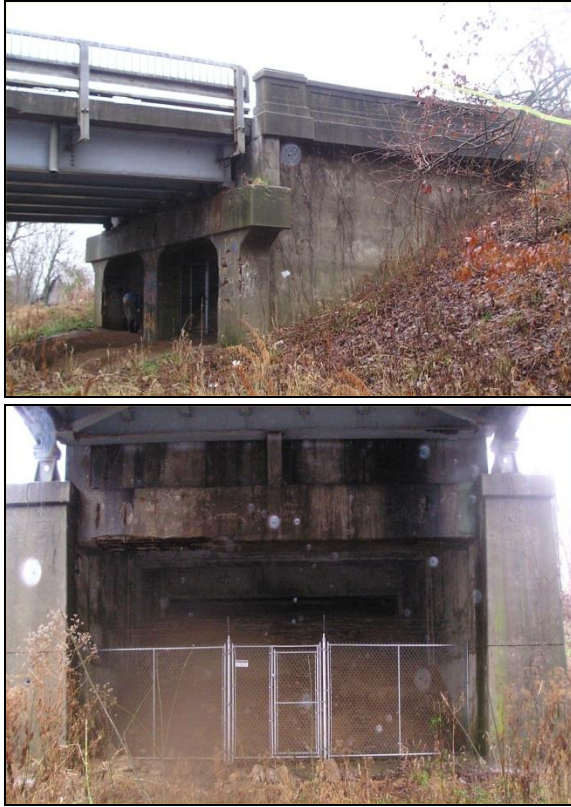
Photo 12 and 13: Bridge Design Mimicking “Cave-like” Atmosphere

While assessing bridges or structures, look for dark environments that mimic cave-like conditions such as under the deck in the case of a bridge (Photos 12 and 13) or an attic in the case of a structure. This may involve crawling under low areas so a hard hat is recommended. Such places (e.g., a concrete bunker secreted into a hillside with an open front) provide protection from wind, rain, sleet, hail and predators. Bats do not roost near the ground where predators (cats, raccoons, etc.) can reach them. Roosting is usually at least 4 feet from the ground.

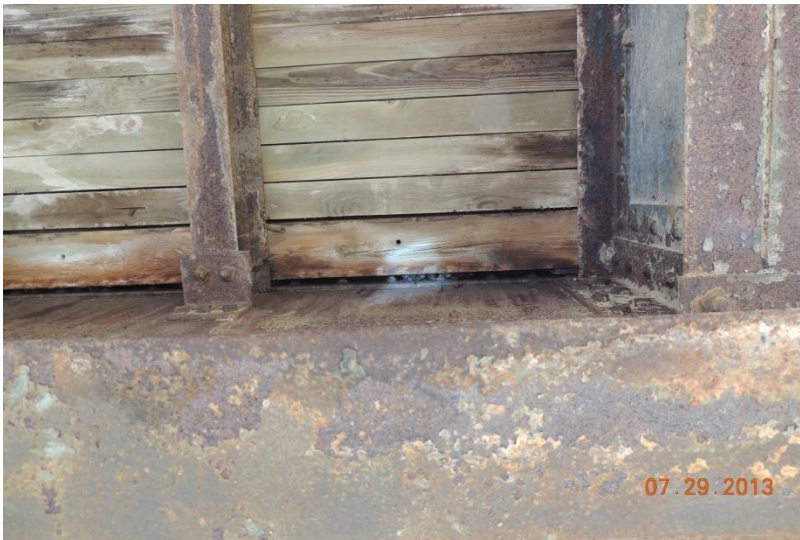
Photo 14: NLEBs Roosting Under a Timber Decked Bridge
